B.C. Volunteer Lake Monitoring Program

SWAN LAKE

(Peace Region)

2003-2005

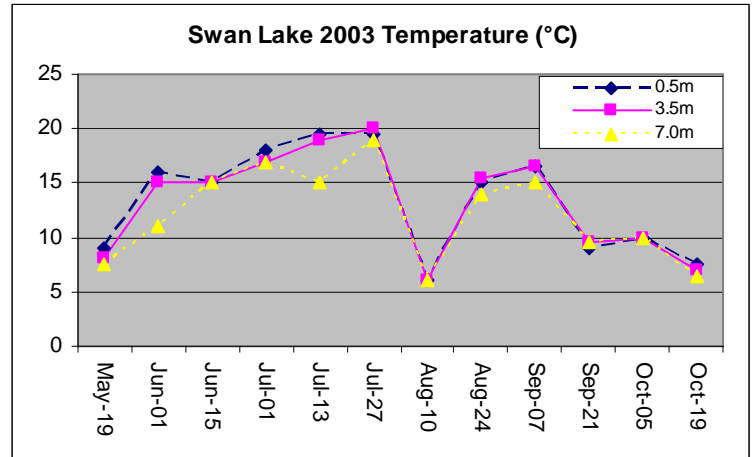
Temperature was measured at the Swan Lake deep station from 2003-2005. The figures on the next column illustrate profiles collected. All three years show the lake beginning to stratify in early/mid May. This stratification appears weak however and does not usually hold throughout the summer. Both 2003 and 2005 appear to lose the stratification in July, while the 2004 stratification appears to hold until late August. Swan Lake water temperature appears to be very sensitive to change in air temperature, evident by the August 10th, 2003 sample when both air (measured at the Provincial weather station in Dawson Creek) and water temperature dropped substantially. The multiple stratifications through the summer are likely due to the shallow depth and open surface of Swan Lake (thus being more susceptible to wind action and water turbulence), which can cause mixing of the stratified layers. Because of these multiple stratifications, the lake is termed polymictic.

Maximum surface water temperatures reached 20°C, 23°C and 19°C in 2003, 2004 and 2005 respectively. Summer average temperature showed 2004 to be the warmest at all three water depths, followed by 2005 and 2003.

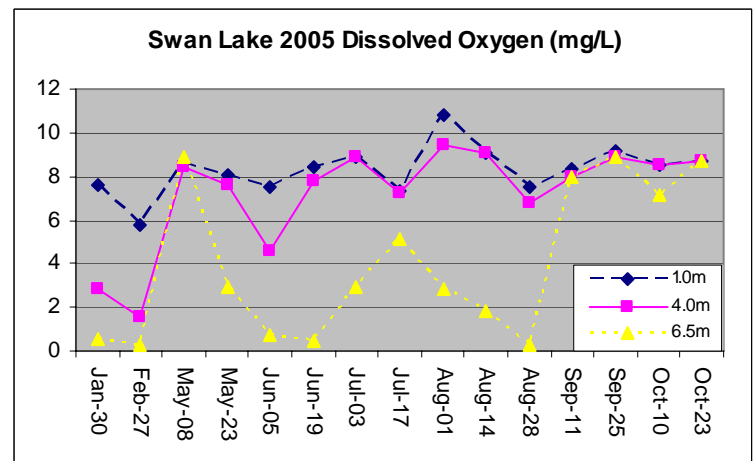
The figures on the next column display oxygen patterns for the Swan Lake deep station from 2003-2005 (dissolved oxygen was determined by the Winkler titration method in 2003 and by a meter in 2004 and 2005). Different patterns were observed in each year, probably attributable to the lakes high sensitivity to air temperature and ambient weather conditions. Generally, the surface level oxygen was near saturation in all three years, showing slight changes throughout the summer, possibly due to changes in temperature and algal densities. Bottom level oxygen in 2004 and 2005 fluctuated around anoxia, which occurred during periods of stratification. When the stratification was lost, oxygen levels increased. The bottom water oxygen depletion appears to occur rapidly in 2004 and 2005, probably due to bacterial decomposition of settled organic matter, which uses up oxygen. The water with less than 4mg/L oxygen (specifically the lake bottom during periods of stratification), would not have supported fish.

The last figure presented is the complete oxygen profile for 2005, with measurements taken at 1m intervals. A few interesting facts are of note, starting with the winter stratification observed on both the January and February dates. There are distinct layers present, with bottom level oxygen approaching anoxia. This stratification is broken in May with spring turnover, however is quickly re-established until September. Most of the lake does mix on July 17th, however the bottom layer doesn't appear to be fully oxygenated (the lake may have totally mixed between sample dates). Following this mixing event, the bottom layer is again depleted of oxygen, while the top 6m of the lake stay relatively close to saturation. The whole lake goes through a turnover event on September 11th, when all layers in the lake have a concentration of 8mg/L.

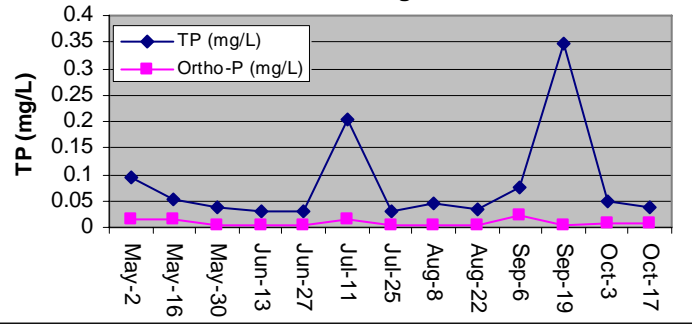
2004 Tupper Creek Phosphorus at the Highway #2 crossing

the year. However, there are instances in each of the three sample years, when there is a very large spike in TP and turbidity at the TC site that is not detected at JS2. Both 2003 and 2004 spikes can be related to heavy precipitation events that occurred prior to the sampling date, and the 2005 spike can be attributed to very warm temperatures in the spring, probably influencing spring runoff. Conversations with local residents did indicate that Tupper Creek is very flashy, and responds quickly to precipitation. As previously discussed, these large TP and turbidity spikes were also detected in the bottom waters at the deep station in Swan Lake. The exact source of the particulate and TP is unknown, however, the area between sites JS2 and TC, as well as the main Tupper Creek drainage, is dominated by agriculture, with some gas wells. The source of the turbidity and TP may be from a combination of sediment from natural and human induced stream erosion, bridge crossings and overland flow from agricultural fields.
